JACOB BEATY and JESSICA BEATY, on  
behalf of themselves and all others similarly  
situated,

FORD MOTOR COMPANY,

Case No. 3:17-v-05201 RBL

**REBUTTAL REPORT OF THOMAS READ**

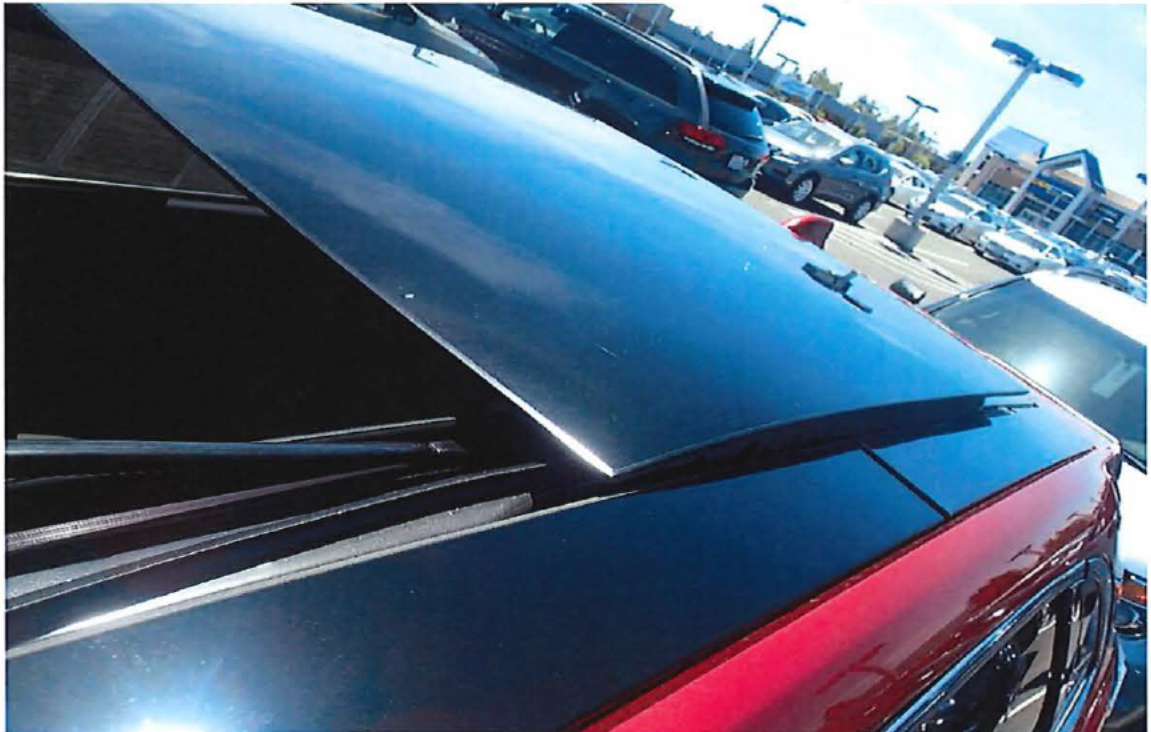
2017 Ford Edge

My inspections of all of these vehicle models and PSRs confirmed that they are materially the same as the Subject Vehicles. Thus, I have examined numerous PSRs that are the same as those included in the Subject Vehicles, and it remains my opinion that the PSRs in the Subject Vehicles, which are manufactured with tempered glass, are defective and that this defect is common to all of the Subject vehicles.

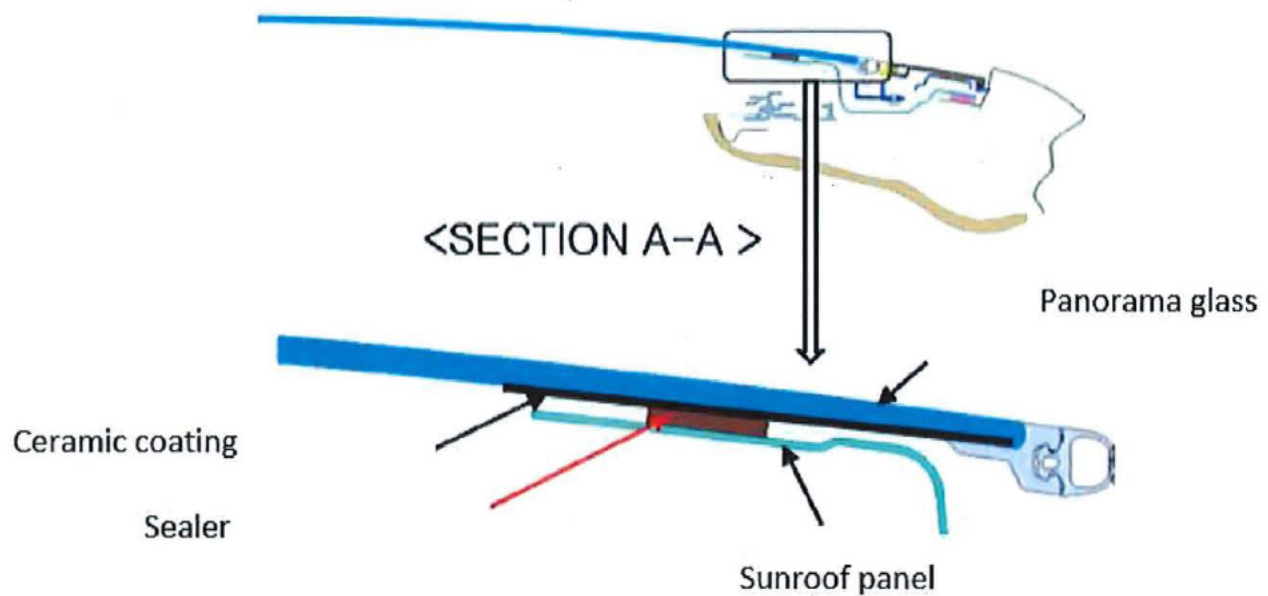
Figure 6: PSR Attachment

As shown in Figure #6 below, each glass panel in the PSRs is affixed to the sunroof frame using a sealant or fasteners. The sunroof frame is affixed to the vehicle frame via fasteners. It is my understanding that these vehicles utilize a unibody construction which means that the entire body of the car, including the sunroof, handles and absorbs the loads and stresses applied to the vehicle.
